Implementation of a ferromagnetic detection system in a clinical MRI setting

Purpose: To evaluate the implementation of a ferromagnetic detection system (FMDS) into a clinical MRI setting.

Materials and methods: One thousand patients were considered for MRI safety screening using an FMDS. Equipment used was a Ferroguard® Screener (Metrasens Ltd, Malvern, Worcestershire, UK). Fully gowned patients rotated 360° in front of the FMDS in a standardized manner following traditional MRI screening methods (the use of a written questionnaire (Fig. B.1) and verbal interview).

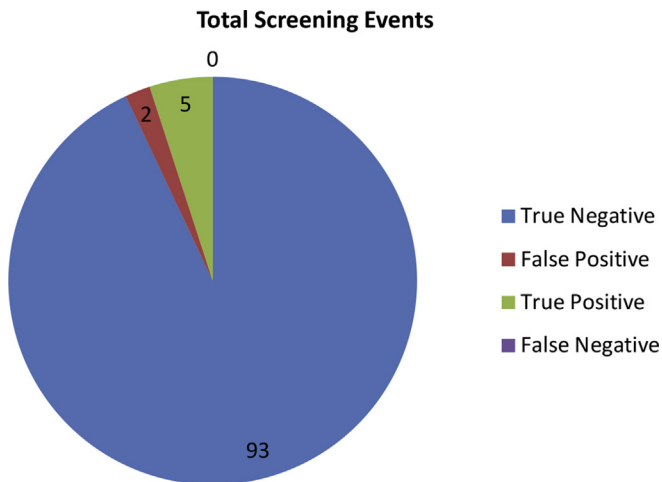
Figure B.3. Graphical representation of total screening event results.

Results: Final results included 1032 individual screening events performed in 977 patients. There were 922 (94%) initial passes using the FMDS; 34 (4%) failed initial screens but passed a subsequent screen; 21 (2%) failed the initial and subsequent screens. Thus, including all screening events (n = 1032), there were 956 (93%) true negatives (TN); 21 (2%) false positives (FP) and 55 (5%) true positives (TP). No false negatives (FN) were recorded. Therefore, sensitivity was 100% and specificity was 98%.
