# MRI Ferromagnetic Detector System: Fatigue Study

By Ronald Bucci, PhD, Robert Ferguson, MD, Holly Frank, RT(M)

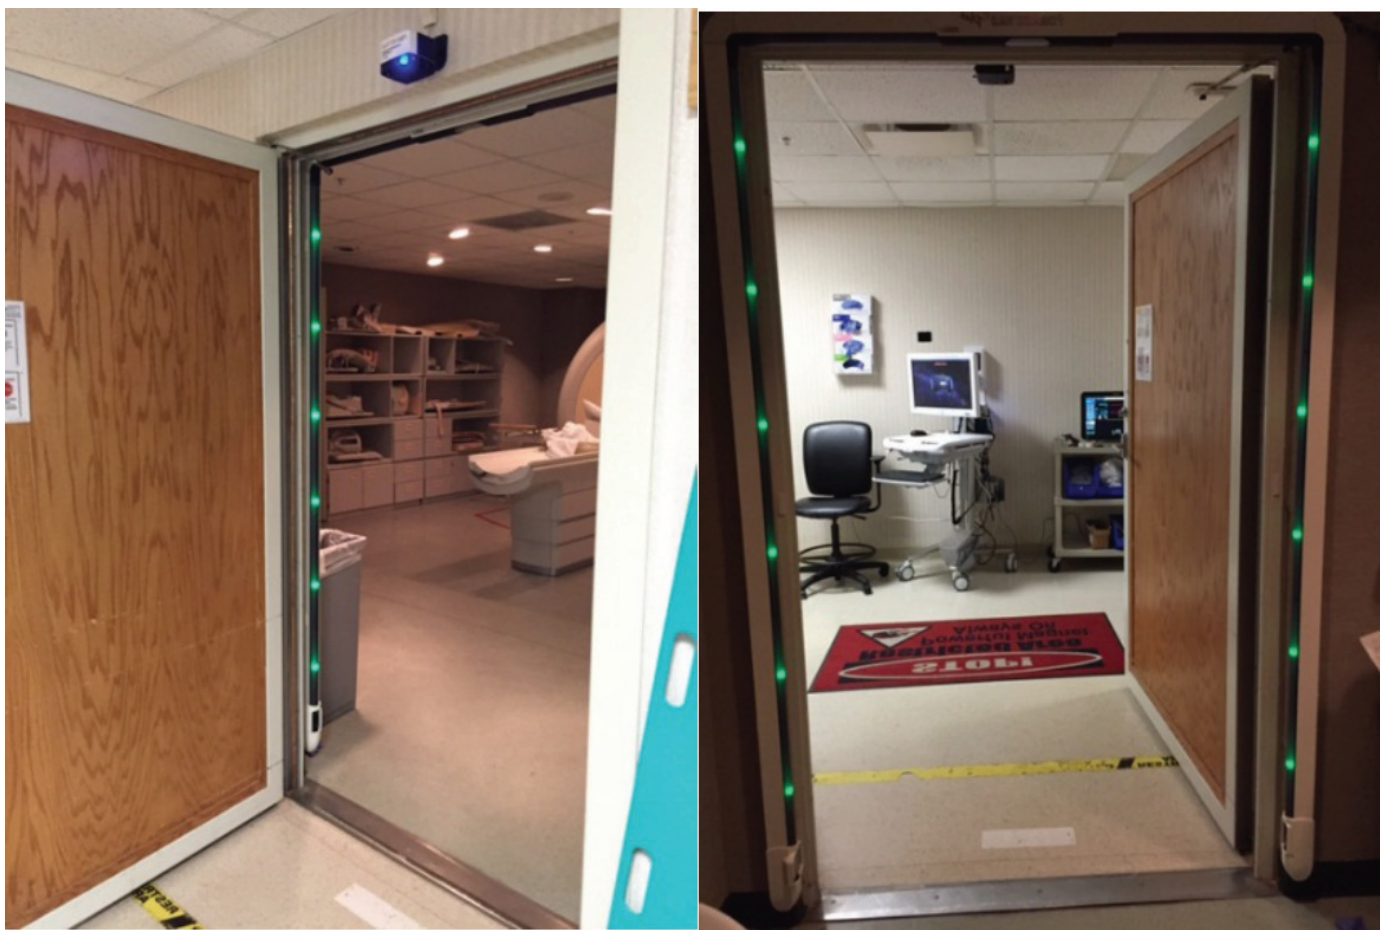
Figure 1 • New Ferromagnetic Detector System

MRI installations were equipped with an electronic magnetic alarm system. The new system used in this study (Figure 1) was placed at the MRI door and was a 3.0 T system unit to be equipped with an incident log manager. It is a device that continuously records images of all personnel who pass through the system into the MRI suite from 5 seconds before the incident occurs until 15 seconds after the incident. This allows identification of persons and objects that are determined to be ferromagnetic and determines whether the effectiveness of such a system would degrade over time due to alarm fatigue in the MRI scanning environment.

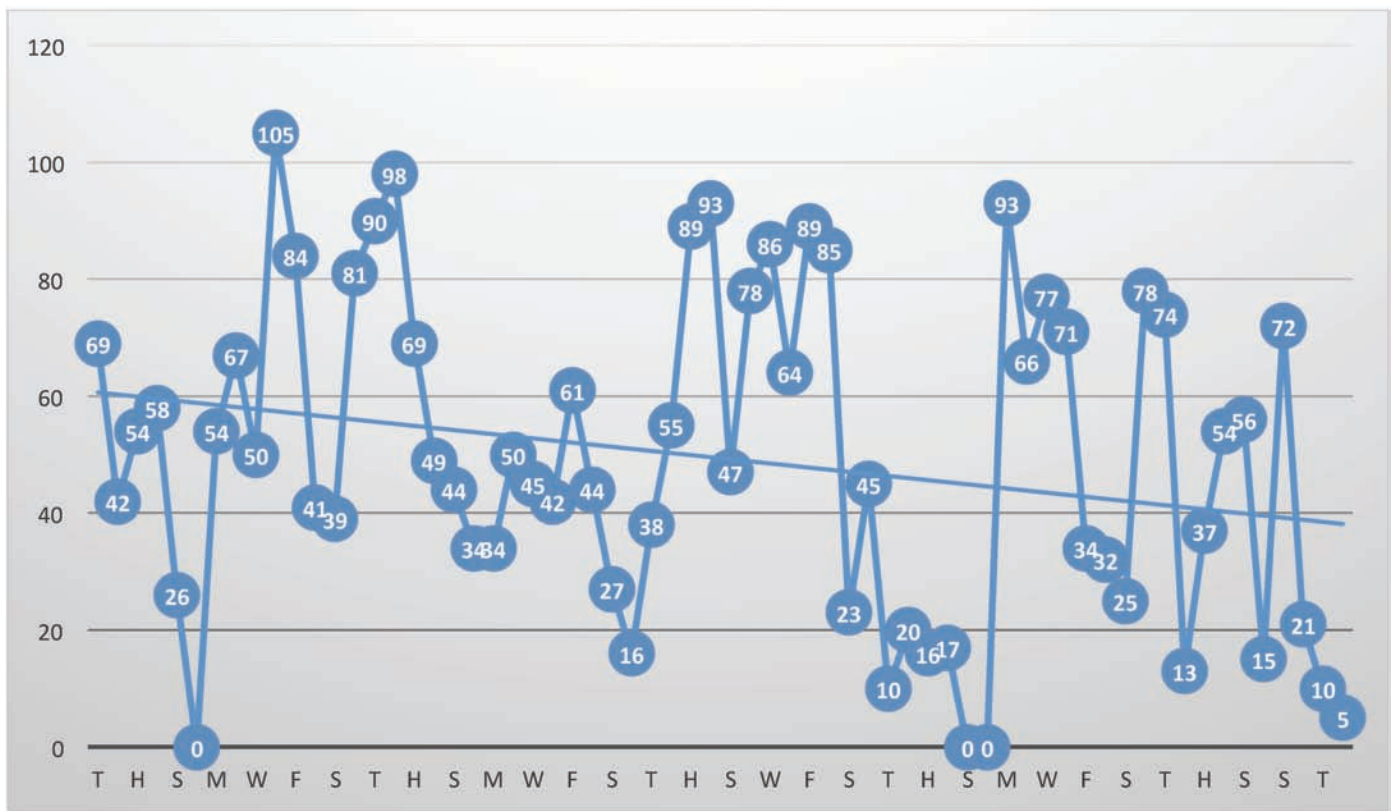
Figure 2 • Number of Incidents Per Day

During the two month study interval, the system recorded 3161 alarm activations as someone entered or exited the MRI

room. This was shown to be an average of 49 alerts per day with the highest number being recorded of 105 incidents or events in a day. The weekend numbers were at a much lower incidence of magnetic detection than weekdays since the volume of procedures was decreased. The average number of incidents in the first week of study was 60 per day and at the end of two months the average dropped to 40 incidents per day as shown in Figure 2.
